User's Guide

Check the ISS's Firmware level

Replace the ISS's Firmware

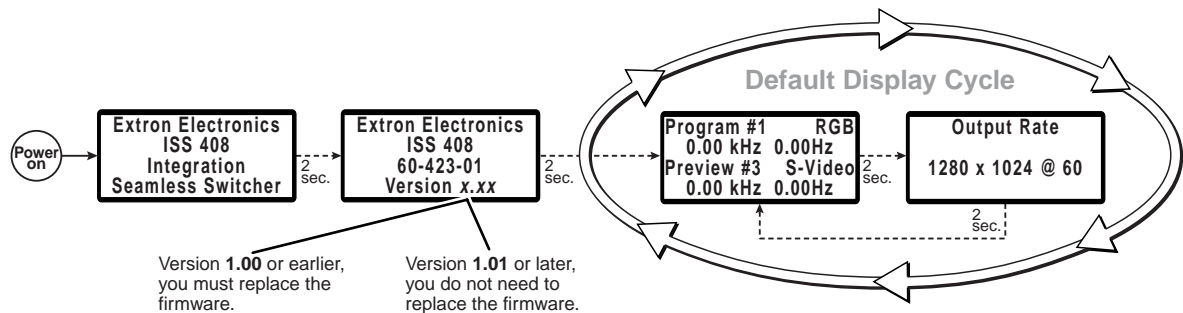
Figure 1 — Identifying the firmware version

The RCP 2000 will work with an ISS 108 or ISS 408 that has firmware version 1.01 or later. Check the firmware installed in your ISS switcher. If the installed firmware is version 1.0 or earlier, install the firmware chips that are attached to this sheet.

Apply power to the ISS. During the power up process, the switcher displays the model name, part number, and the **firmware version** in its LCD display (figure 1).

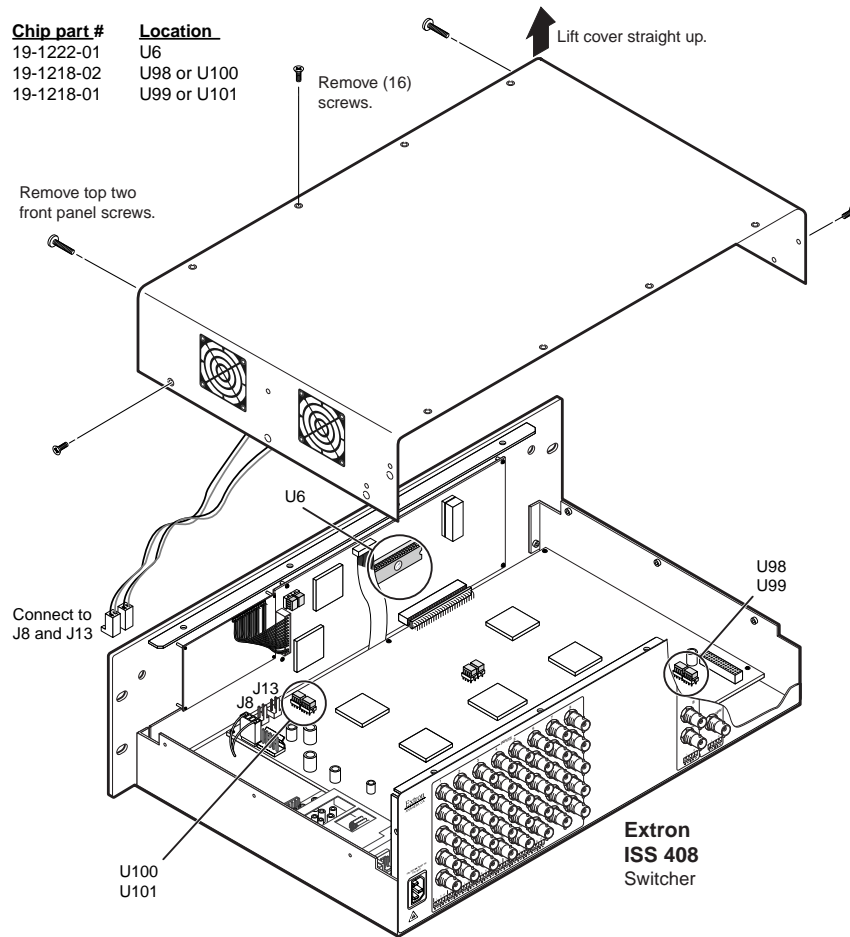
Figure 2 — Opening the switcher and firmware locations

6. Disconnect the two fan power cords from connectors J8 and J13 on the main board.
7. Lift the top cover out of the way.
8. Locate firmware chip U6 on the front panel circuit board and chips U98, U99, U100, and U101 on the main circuit board (figure 2).

9. After you are electrically grounded, use a DIP chip puller to grasp the IC chips and pull them out of the socket.
10. The table in figure 2 identifies the socket into which each firmware chip is to be installed.

NOTE Ensure the correct chip is installed in each socket. The wrong chip will not work and may damage the ISS.

The U98 and U100 chips are identical and can be installed in either location.

The U99 and U101 chips are identical and can be installed in either location.

11. Align the notches on one end of each chip with the notches in the socket in the same orientation as the old chips. Gently, but firmly, press the chips into place in the socket.
12. Reconnect the two fan power cords to connectors J8 and J13 on the main board. It does not matter which fan is connected to which connector.
13. Replace the top cover on the ISS.
14. Fasten it with the screws that were removed in step 3 and step 4.
15. Rack mount the switcher if desired and reconnect all cables.
